# Manhole Inspection Summary

Manhole # S35M\_\_005MH

**Inspection** ☐ Is Incomplete Rating: **5) Immediate Attention Required**

**Location** Address: **601 light st**

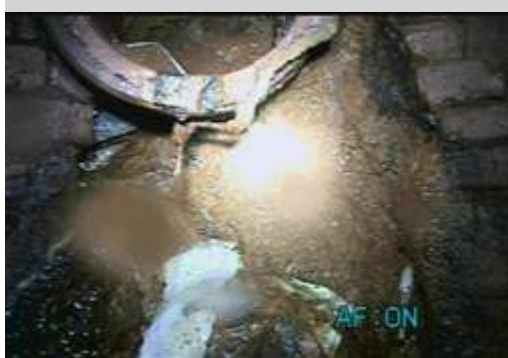
Defect 6

Infiltration: ☐ None ☐ Joint ☐ Cracks ☐ Mortar ☐ Roots ☒ **Wall**

infiltration in corbel

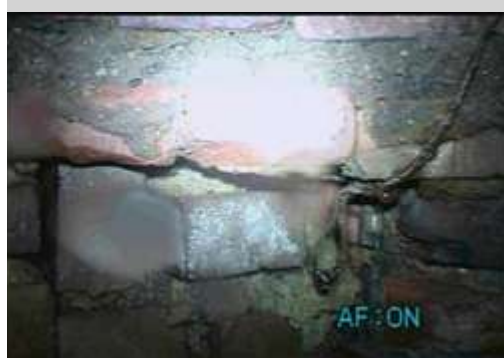
Defect 5

Condition: ☐ Sound ☒ **Cracked** ☐ Root Intrusion ☒ **Loose Brick** ☒ **Deteriorated**

cracked and deteriorated barrel

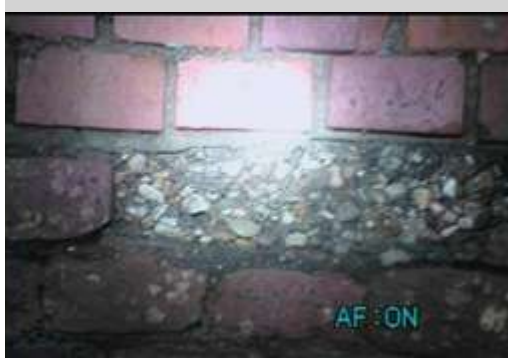
Defect 4

Condition: ☐ Sound ☐ Cracked ☐ Root Intrusion ☒ **Loose Brick** ☒ **Deteriorated**

deteriorated (hole) in corbel

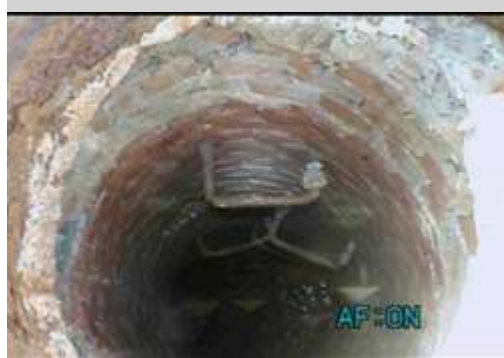
Defect 3

loose bricks in corbel

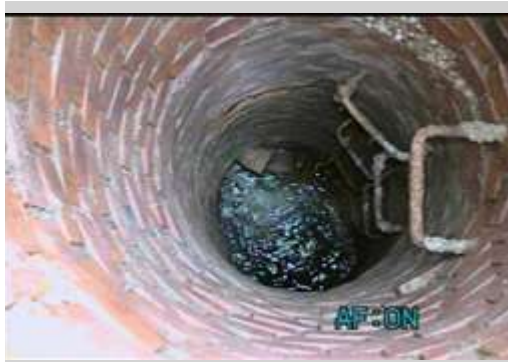
Defect 2

Count: **12** Missing: **0** ☒ **Corroded**

steps

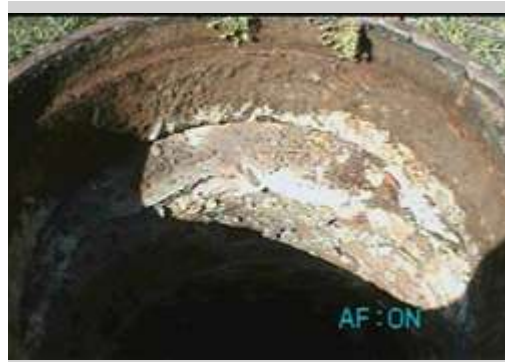
Defect 1

Offset: **5** (in.)

Condition: ☐ Sound ☒ **Cracked** ☐ Leaks

cracked frame, offset

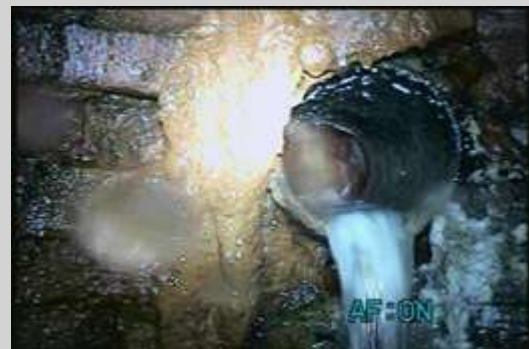
Drop In @ 5 O'Clock

Drop Condition: **Clogged**
